**Architectural Impact Assessment for the remnant excavations
and structures on Erf 29 of 3 of Leeuwbosch 1275,
Brookwood Manor Farm, Fort Nottingham**

August 2010
Prepared for: Mr D Robinson
Brookwood Manor Farm
Fort Nottingham

Architectural Impact Assessment for the remnant excavations and structures on erf 29 of 3 of Leeuwbosch 1275, Brookwood Manor Farm, Fort Nottingham

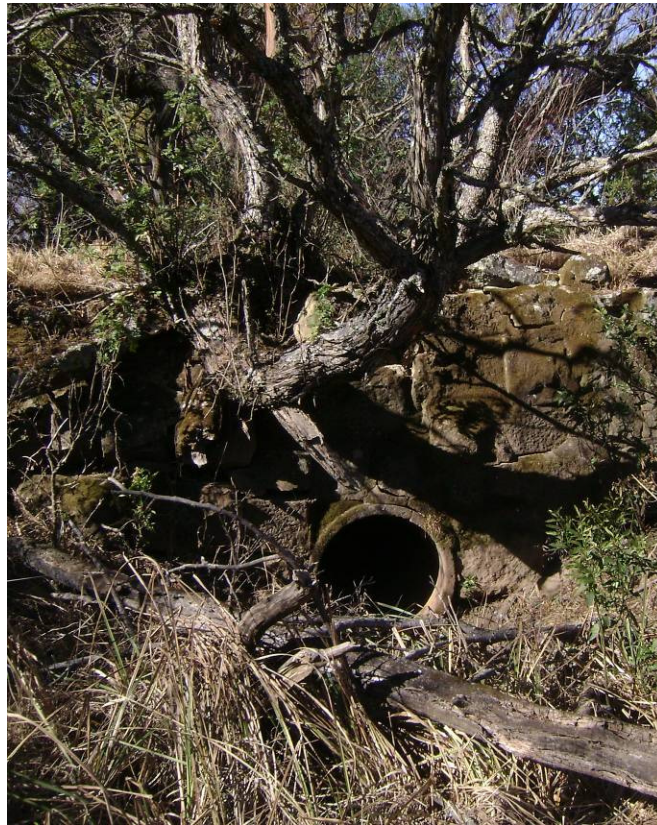
Scour pipe, old mill pond wall Photo: Author 2010)

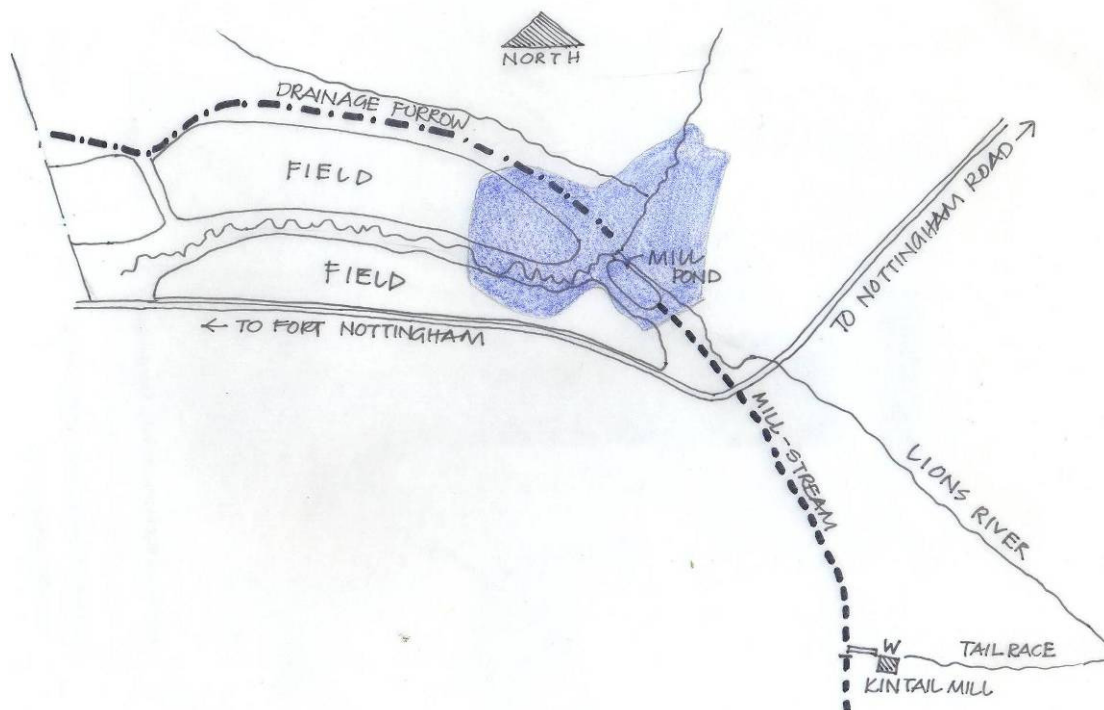
Fig 1: showing the excavations on site, as well as the impact of the proposed dam

The intention of the owner of the property, Mr D Robinson, is to flood the lower parts of the property in order to create a dam. In this process, a previous dam that was on the site, now known to be a breached mill- pond, will be covered by water, in addition to irrigation furrows that were once dug to drain a wetland which drained into the Lions River. See figure 1 above.

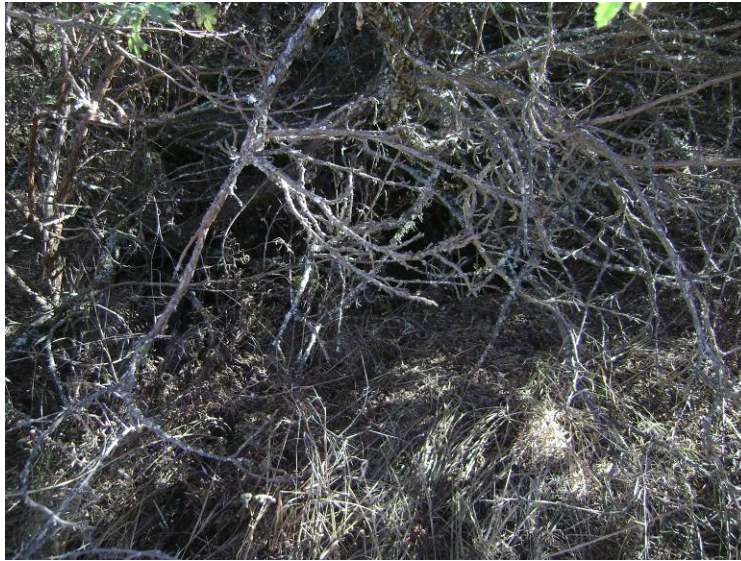
The drainage furrow runs from west to east, from the old Nottingham Bush towards the Lions River. See Fig 1. Its function was to clear the vlei that was immediately to the south of it, so that the land could be employed for agricultural purposes. It is on average around 750mm deep. Given the notes by Gordon McKenzie below, this excavation would possibly date to the late 19th century.

The drainage furrow is currently largely obscured by established trees, *Leucosidea sericea*, many of which are rooted in its base. It begins on higher ground and then peters out close to the confluence of the river tributaries.

Fig 5: Drainage furrow

The first excavation that will be affected is that of the drainage furrow. The construction of drainage furrows to drain vleis is described in detail by Gordon McKenzie, where he refers to his family implementing these, describing those on the adjoining farm Cotswold in particular (McKenzie; 196-). Currently the drainage furrow is covered by *Leucosidia* thickets, and is largely obscured. This is a good example of late 19th century pioneering farming techniques, in order to release land for agriculture and pastures. Little of this excavation is celebrated, and its existence is most likely is not widely known.

Inundation of the drainage furrow would not remove a vitally celebrated heritage resource from the local community. Examples, it would appear, also exist on Cotswold.

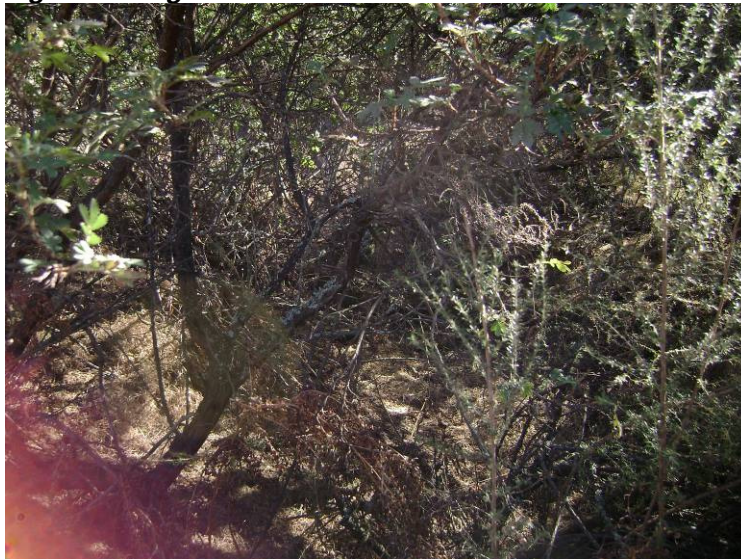
Fig 6: Drainage Furrow

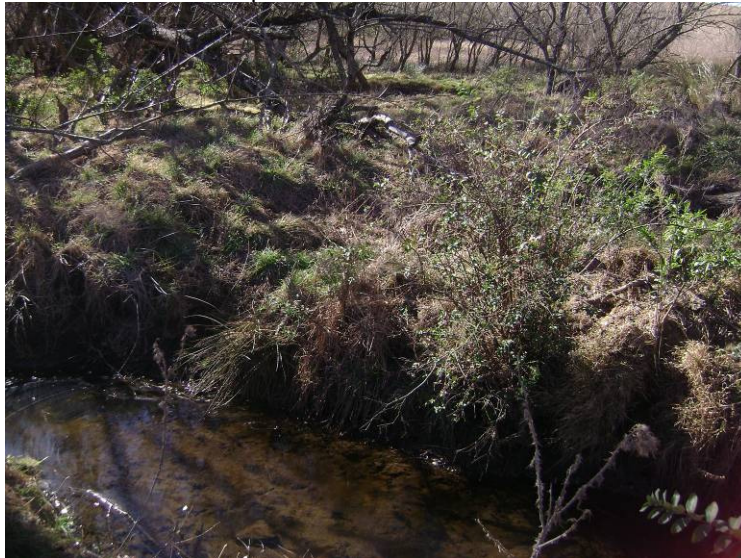
Fig 6: river feeding the northern end of the mill pond

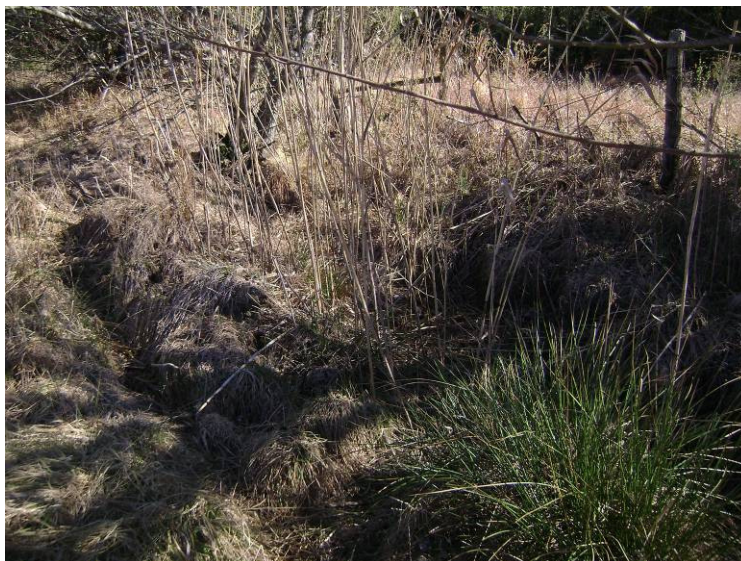
Fig 7: channel leading into mill pond

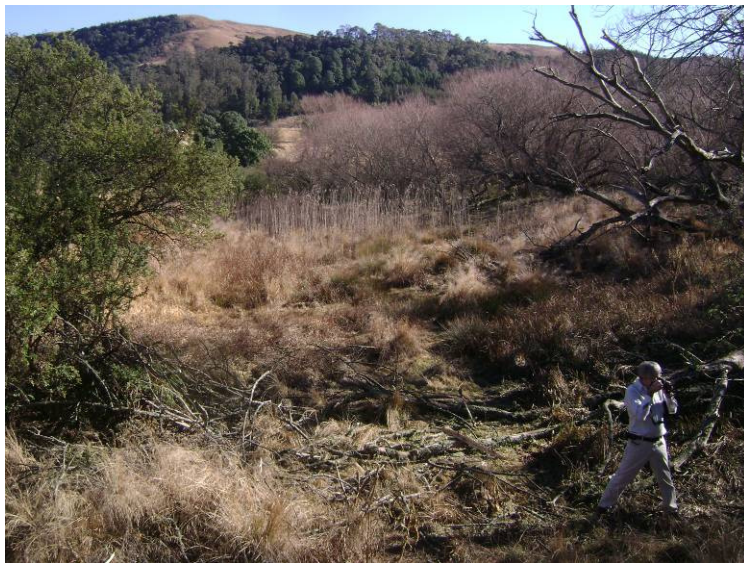
Fig 8: Looking back towards river from top of mill pond wall

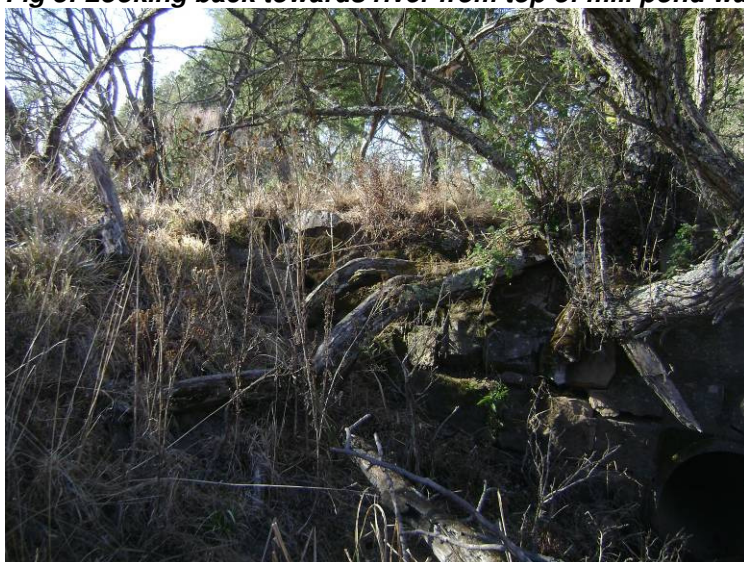
The mill pond formed an integral part of the milling system, as it collected a body of water when needed, which could be controlled in order to drive the mill. The millpond in this case consists of a shallow depression, about 2.5m deep, formed by the construction of an earth berm in close proximity to a bank. The one end was fed from the river along an excavated channel, and the other enclosed with a wall of rubble fieldstone construction which has a sluice pipe or scour pipe of pre-cast concrete (see fig 11). Enquires as to the earliest use of precast concrete pipes revealed that early pipes out of cement would have been individually made on demand by the end- user, and could have been cast *in situ* using locally derived formwork. There is no sign of the pond having breached, and it is suspected that its use concluded with the closing of the mill.

The mortar in this wall is lime. There is a large willow tree growing at the apex of the wall, estimated at some 30 years old. Much of the wall has crumbled.

Fig 9: mill pond wall

However, the mill pond and a small section of the mill stream are intended to be covered by water with the construction of the proposed dam. Despite their contribution to what was at one time a locally important facility, they are defunct and overgrown. Like the example of the drainage furrow above, they have little local importance individually or as part of a system which has been largely forgotten.

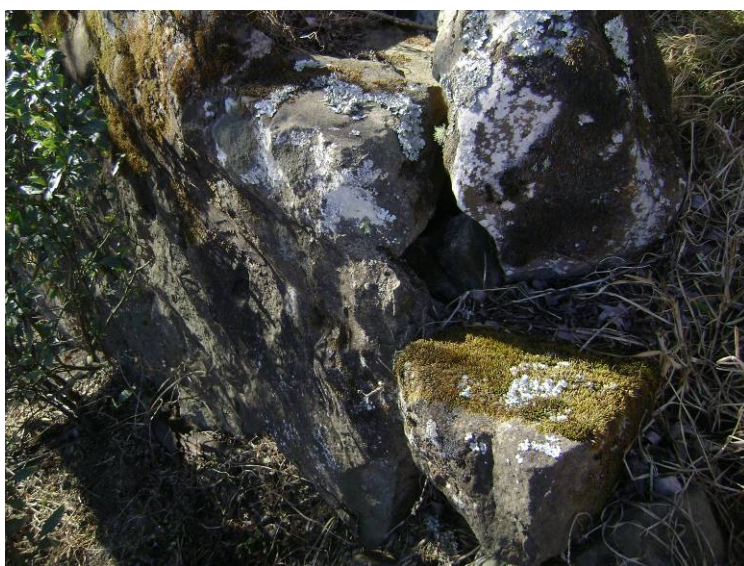
Fig 10: wall construction

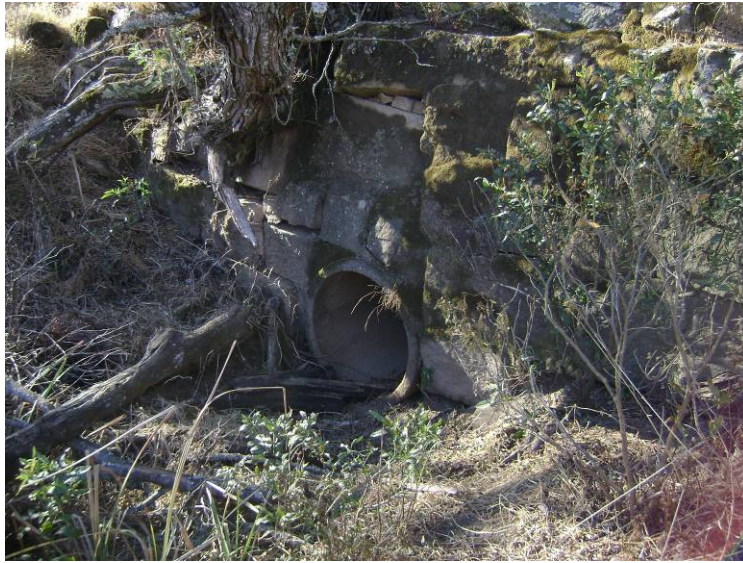
Fig 11: pipe at base of wall from inside mill pond

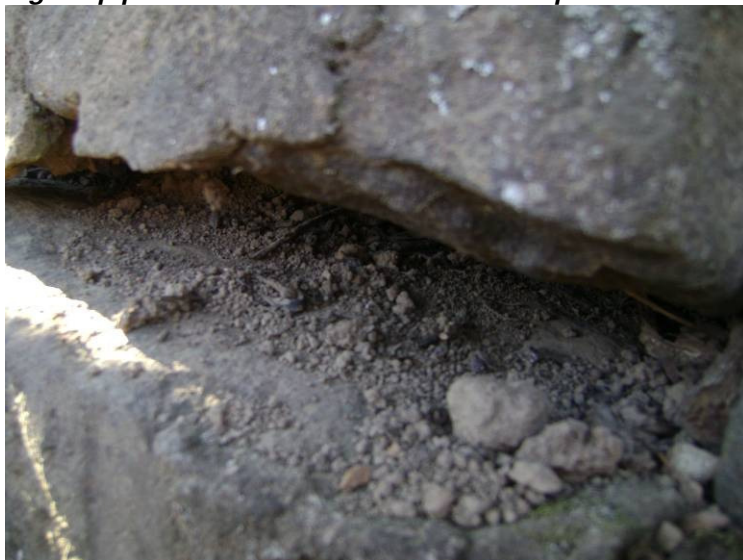
Fig 12: Lime mortar joints

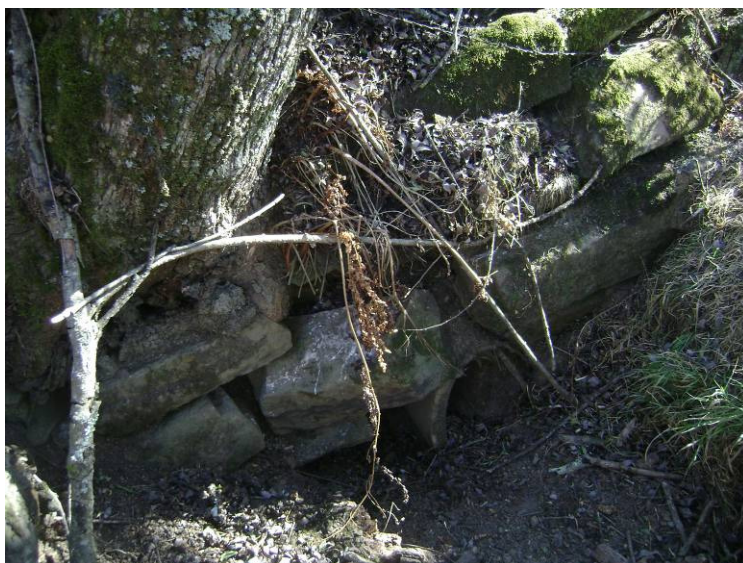
Fig 13: pipe and wall on mill stream side of the wall- note willow tree

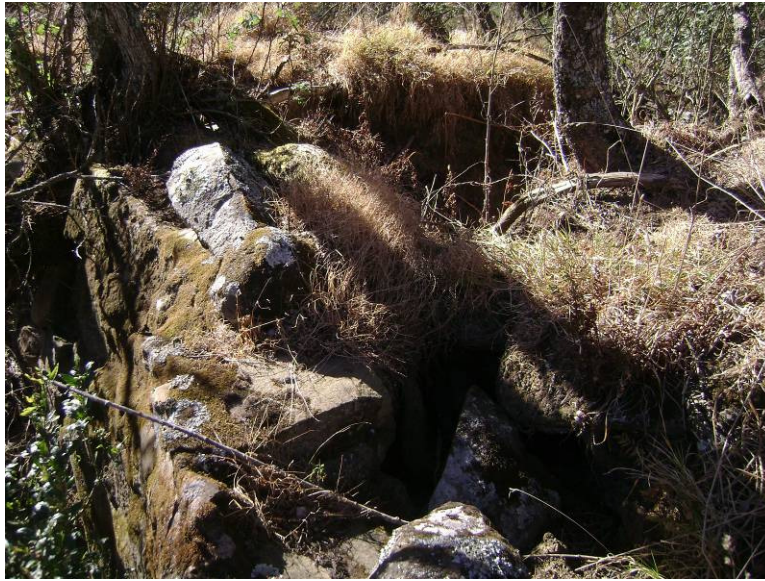
Fig 14: top of mill pond wall

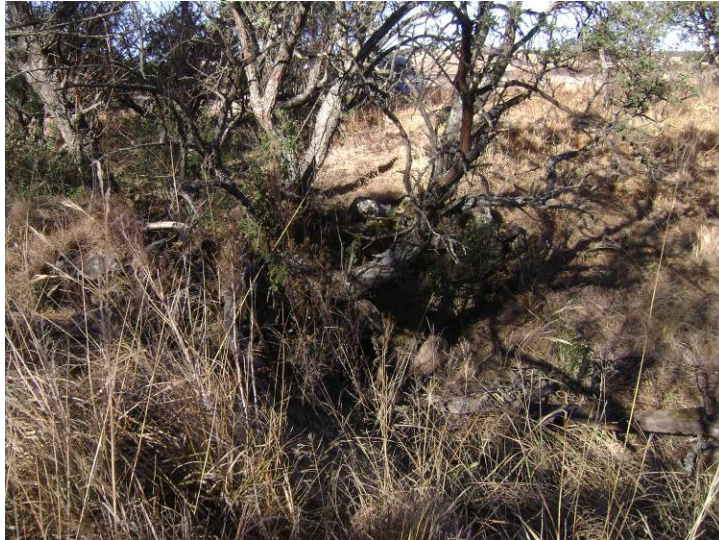
The millstream is an excavation that carried the water for milling, when let out of the mill pond. It is a shallow depression ranging from 1.2m to as little as 100m. Some distance along is a diversion, which leads back into the river. This is suspected as being an overflow, controlled by a deeply excavated hole. the section of millstream on the property in question lies in thick *Leucosidia*, and across the road, on Kintail farm, is evident as a shallow depression following the contour leading to the mill.

Fig 15: Mill stream

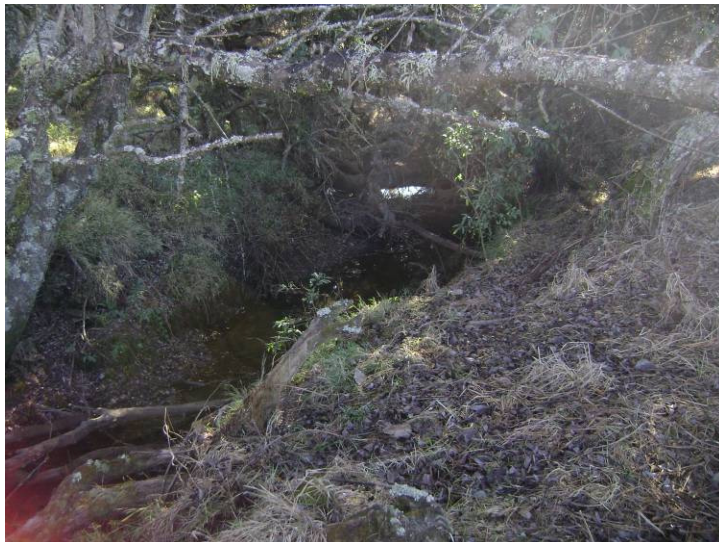
Fig 16: Overflow into Lions River- natural Flood Hatch (see Walton: 1975: 69)

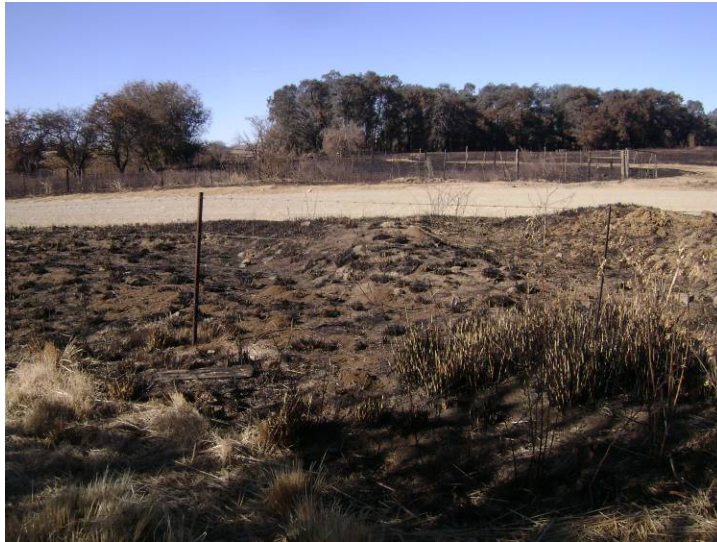
Fig 17: Mill stream crossing the road

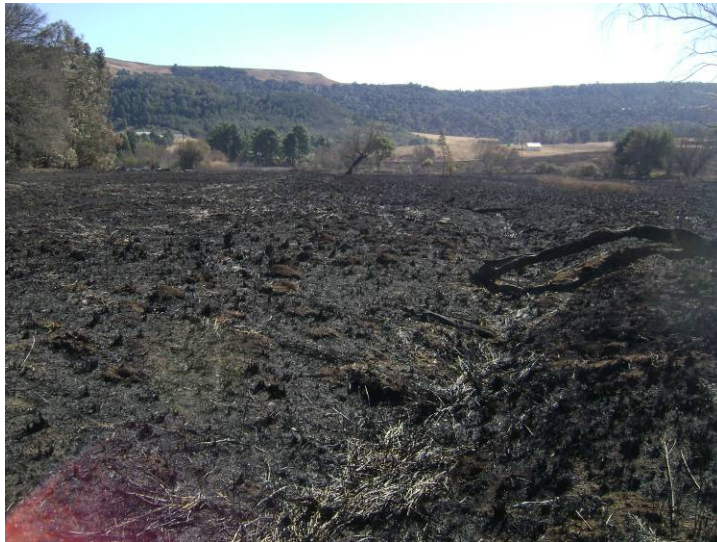
Fig 18: Mill stream looking back towards mill pond

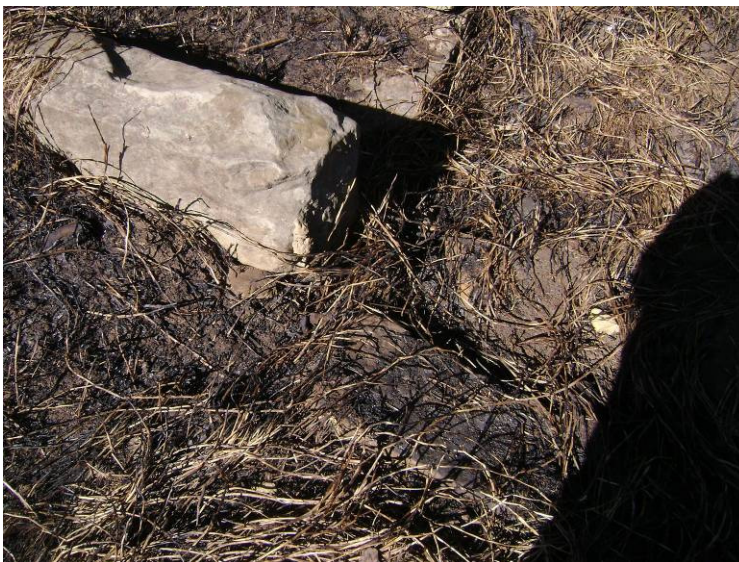
Fig 20: Entrance to mill race where a penstock would have controlled the flow of water.

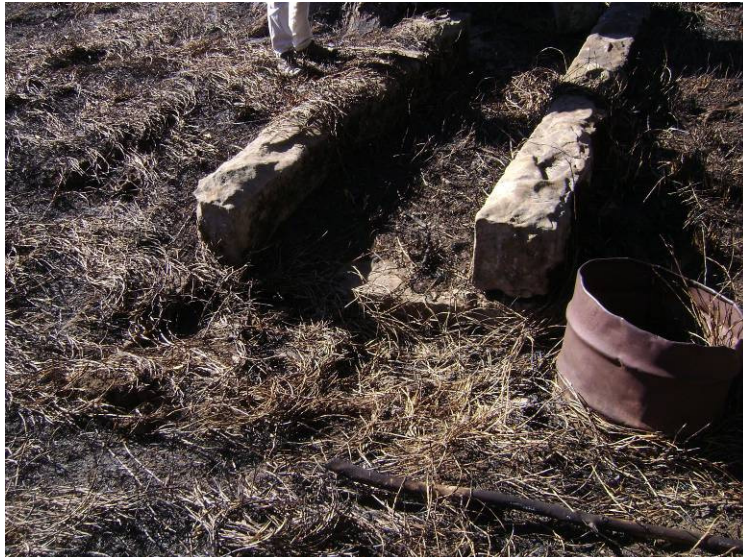
Fig 21: entrance to mill race from mill stream

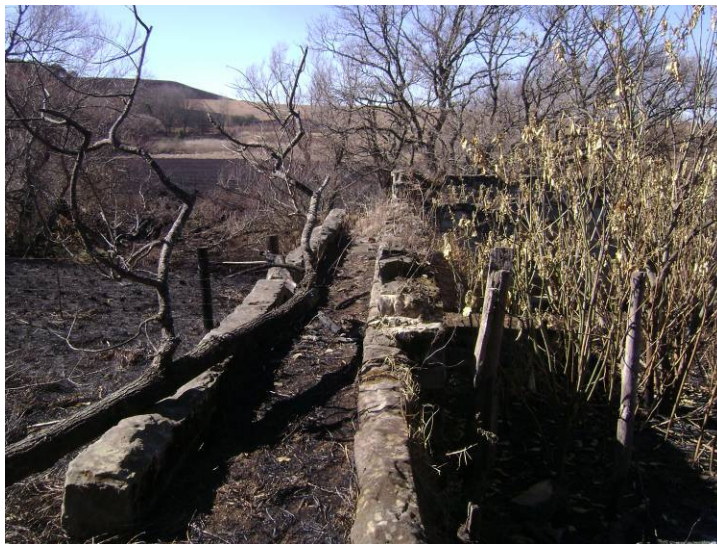
Fig 22: Mill race looking towards mill (on right)

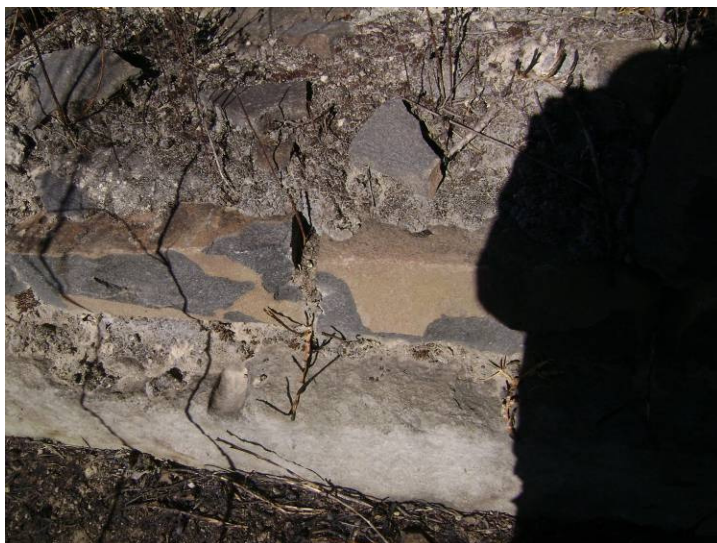
Fig 23: dolerite fieldstone in lime mortar beds

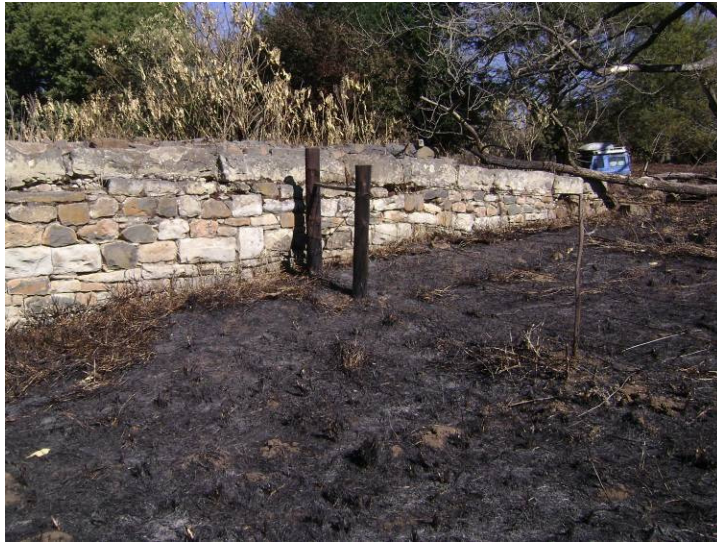
Fig 24: Mill race showing elevation to reach mill

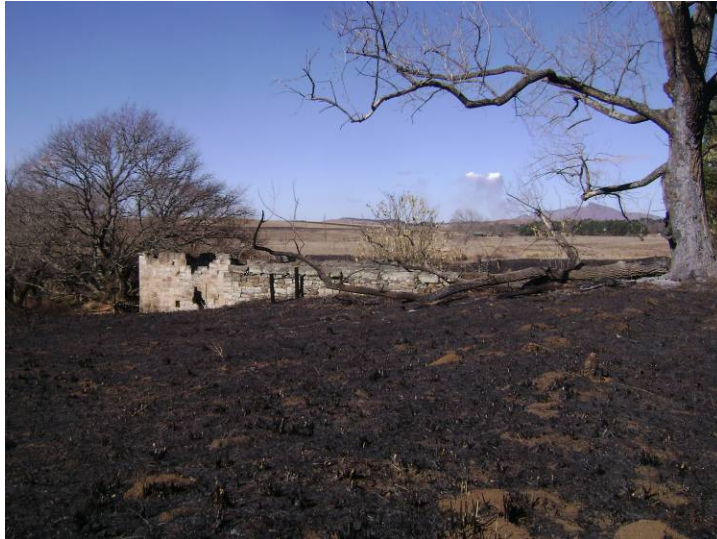
There is no evidence of the steel overshot wheel, or millstones. Internally there were two floors, with a suspended timber floor which has been long destroyed or removed. The walls are of fieldstone which is roughly coursed, and besides major holes in them, structural damage is in evidence with collapsing lintols. The mill has no roof. To the north- west is a series of terraces, adjoining the mill race, where burnt timber posts indicate a rough extension.

Fig 26: View of mill from mill stream

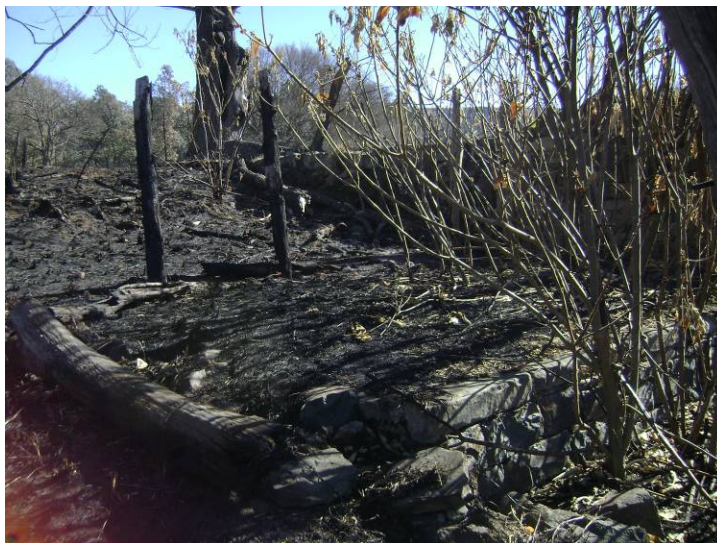
Fig 27: Mill race from the Mill, showing gumpole supports for extension

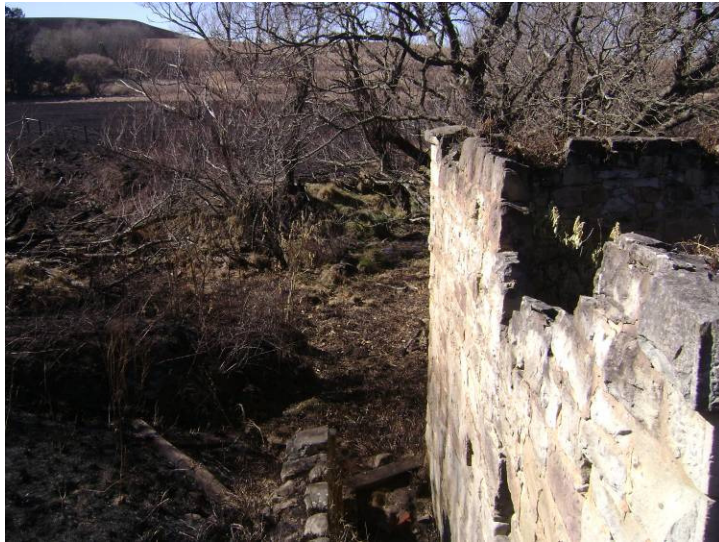
Fig 28: Looking out towards the tail race returning water to the Lions River

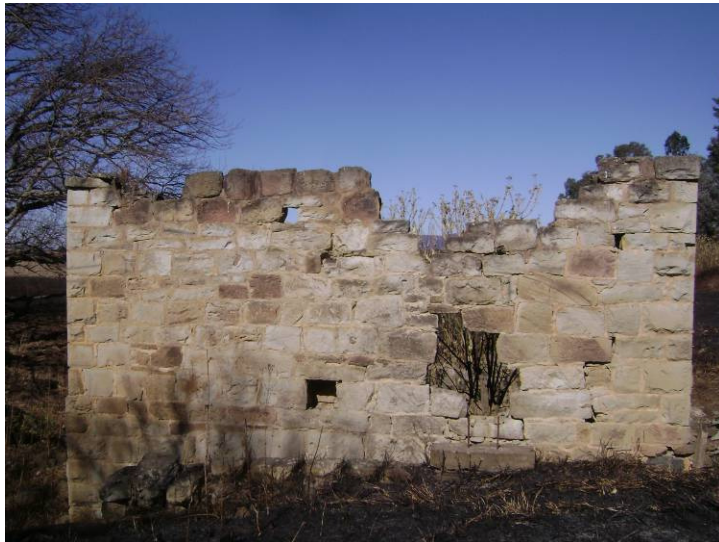
Fig 29: view back across mill pit. Note cavity where wheel and mechanism were removed

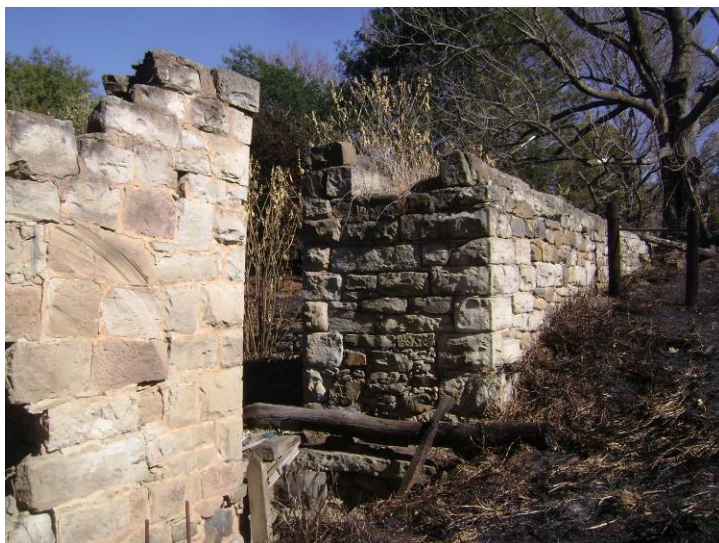
Fig 30: Showing relation of mill race to mill. The flume would have cantilevered out across this gap. Note scour mark from wheel to left

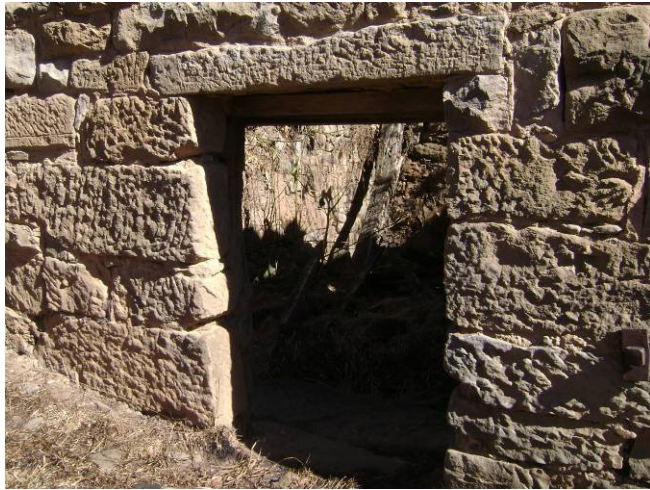
Fig 31: Entrance to lower floor from below

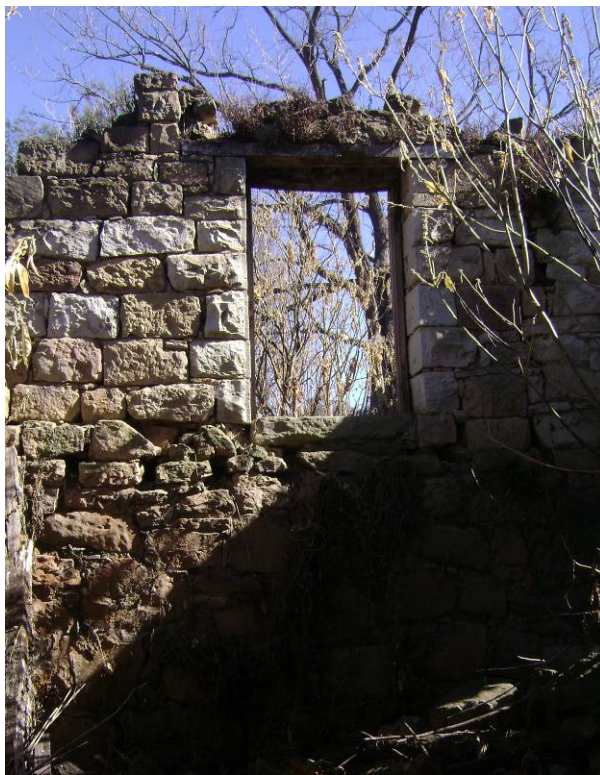
Fig 32: Inside of mill

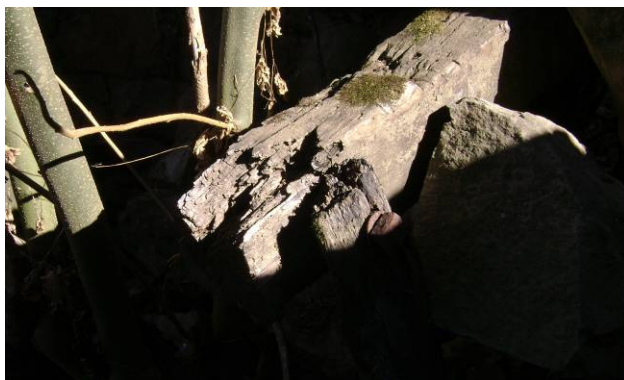
Fig 33: suspected remains of the launder support

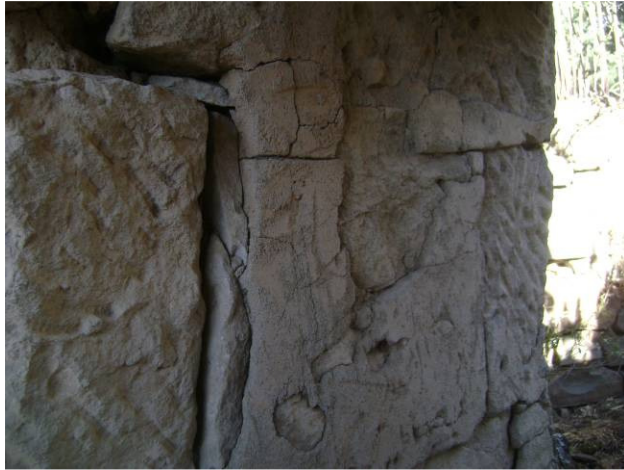
Fig 34: showing lime mortar to joints

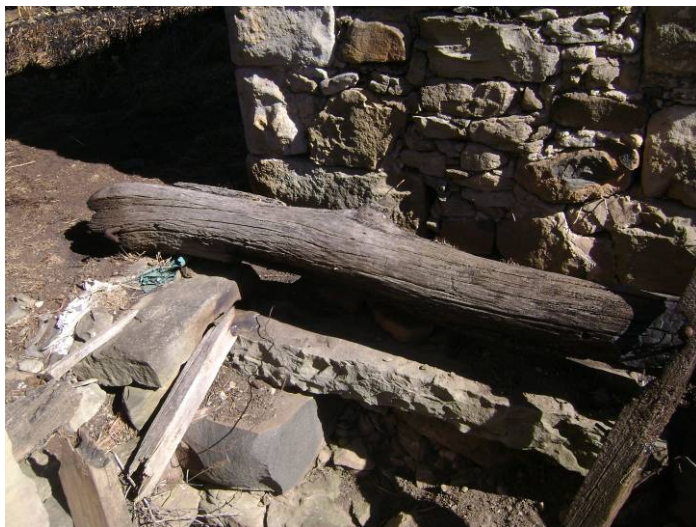
Fig 35: position of laundry support between mill race and mill pit

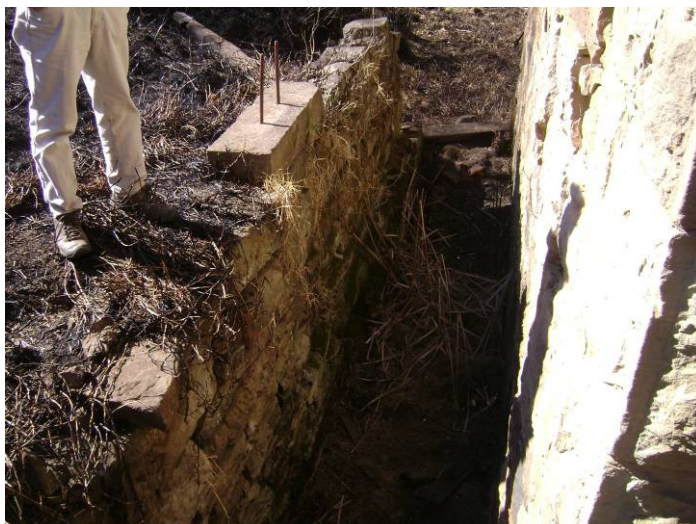
Fig 36: Showing Mill pit
